**ALDON MILL POND DAM  
CT 00622**

**PHASE I INSPECTION REPORT  
NATIONAL DAM INSPECTION PROGRAM**

**MARCH, 1981**

Identification Number:	CT 00622
Name:	Aldon Mill Pond Dam
Town:	Vernon
County and State:	Tolland County, Connecticut
Stream:	Tankerhoosen River
Date of Inspection:	November 6, 1980

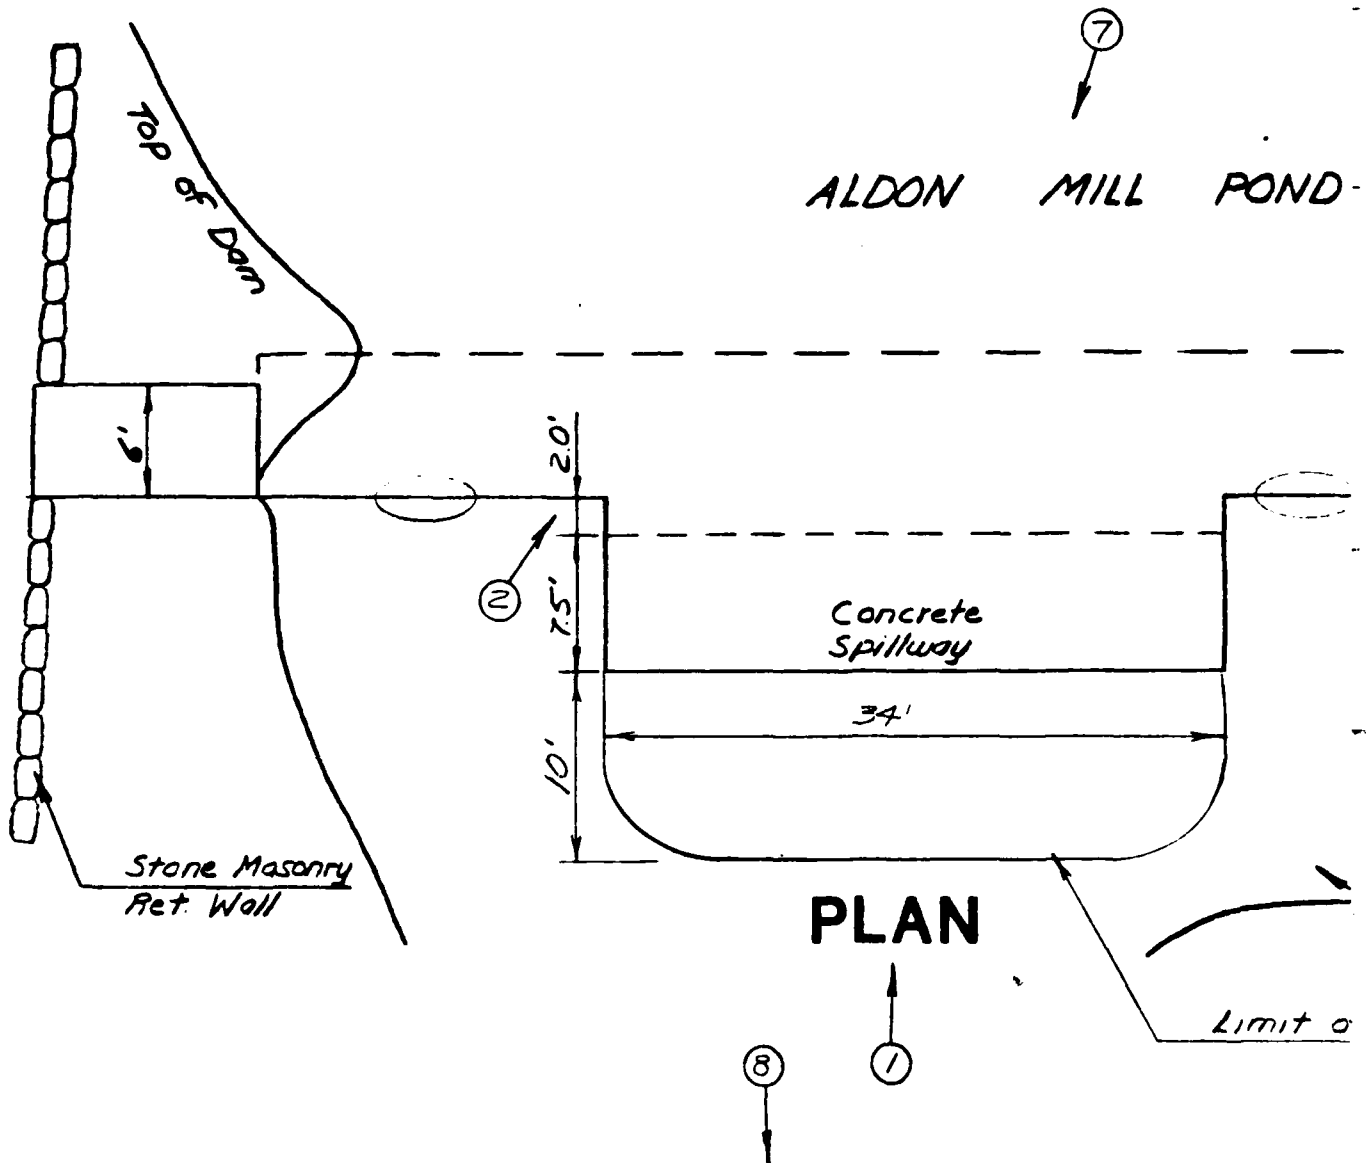
○ Denotes Location of Missing Stones  
In Masonry Face
